## Building Inspection Report

New Building Inspection - Lockup Stage

# APBI Building Inspection Report

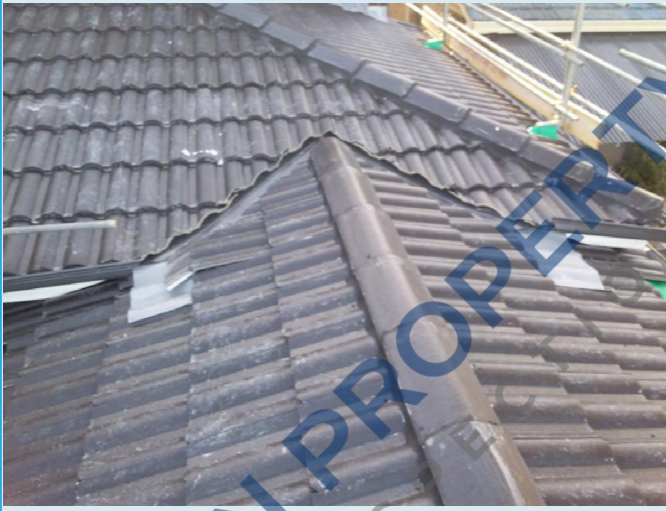
External	
Repair Recommended	Roof
Comments	
<p>Rectify rear roof junction valleys flashings and tiles to sit flat.</p> <p>Rectify fascia and gutter either side of valleys to sit level.</p>

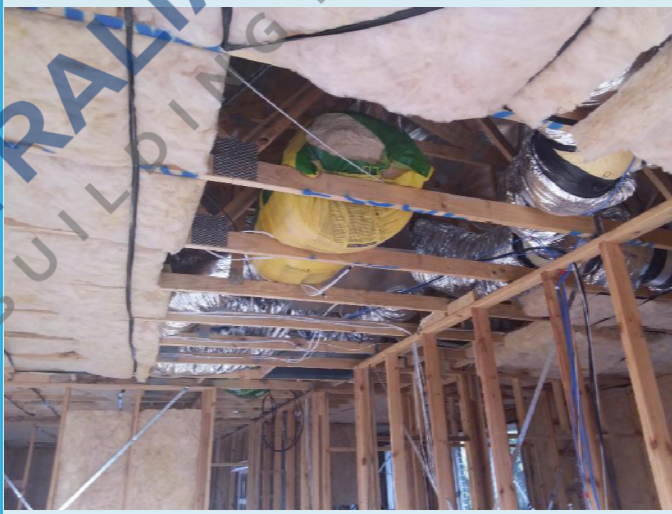
Internal	
General Advice on Item	Insulation
Comments	
Roof space insulation over upper hall to be completed.
