Building Inspection Report

New Building Inspection - Pre Slab Stage

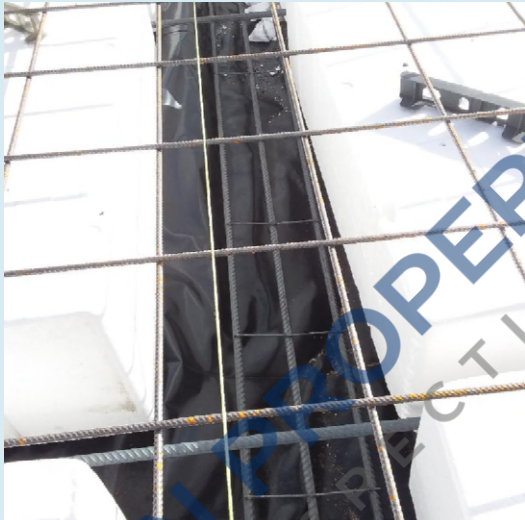
Pre-Slab	
Repair Recommended	Trench Mesh & Steel Reinforcing
Comments	
<p>Trench mesh in footing running through dwelling from garage running East/West requires additional bar chairs to be installed to adequately support it during concrete pour.</p>
